## Scientific article

**Long-term quality management  
of third-generation LED light-  
curing units: A 10-year  
retrospective analysis**Accepted: February 11, 2026  
DOI: 10.61872/sdj-2026-01-04  
2026, Vol. 136  
CC BY-ND 4.0**Christian Klein<sup>1,2\*</sup>, Silke Dengel<sup>1</sup>, Christian Meller<sup>2§</sup>, Christina Meller<sup>1§</sup>**<sup>1</sup> Healthcare Center Meller Zahngesundheit Schlauzahn MVZ GmbH, Waiblingen, Germany<sup>2</sup> Department of Conservative and Pediatric Dentistry, Periodontology and Endodontology, University Hospital for Dentistry, Oral and Maxillofacial Surgery, University Hospital Tübingen, Tübingen, Germany

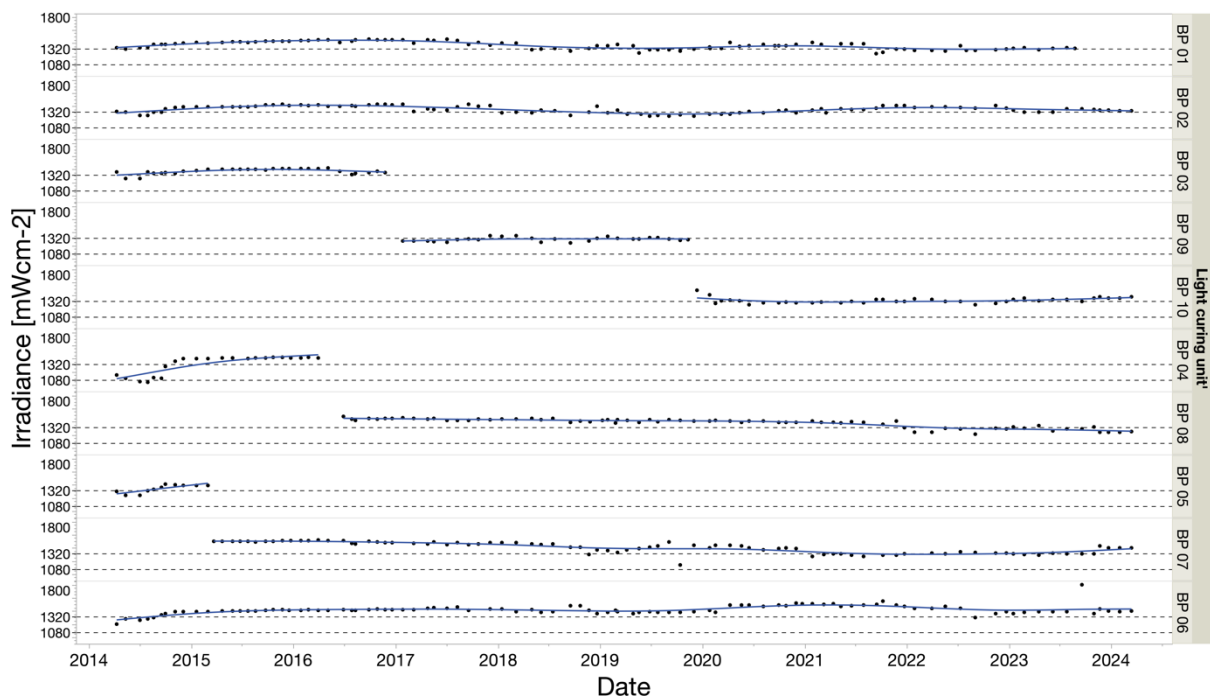
handpiece, the light probe and battery could still be used. In one case (6.25 %), the measured irradiances fell below the range of  $(1,200 \pm 120)$  mW/cm<sup>2</sup> specified by the manufacturer (Figure 1 and Table 1 – BP 04). In this case, the lamp itself was not defective and normal irradiance parameters were successfully achieved by replacing the light probe with a new one.

**Figure 1.** Overview of the tip irradiance measurements with a Bluephase Meter (Ivoclar Vivadent AG, Schaan, Liechtenstein) over a ten year period. The dashed area shows the performance of the  $(1,200 \pm 120)$  mW/cm<sup>2</sup> of the High Power curing program.

This research report is the first to demonstrate the performance stability of third-generation LED LCUs over a 10-year period. The gradual loss of light output from LCU BP 04 (Figure 1), resulting in the replacement of the light probe, shows that despite the noteworthy stability of LED LCUs, regular monitoring should not be neglected. A common reason for the loss of tip irradiance can be the build-up of RBC remnants on the light probe of the LCU. Studies examining the condition of the light probe tip in dental offices found contamination rates of 35-80 % (24, 29, 32, 50-52). Only one study showed no loss of light output despite contamination of the tip (52). Therefore, for quality assurance purposes, a cling film is pulled tightly over the tip of the light probe in the healthcare center where the measurements presented were performed and fixed with the eye protection filter of the LCU to prevent contamination of the tip. No differences were found when measuring tip irradiance with or without cling film (data not shown), which is in agreement with Scott et al. (53). Soares et al. showed a 5-8 % reduction in light output measured with a laboratory-grade radiometer for correctly applied barriers, whereas wrinkled barriers showed a 14-26 % reduction (54). Mitton et al. found that cling film was not effective in preventing cross-contamination due to microscopic holes (32). Since the use of rubber dam is also standard in the pediatric department of the healthcare center, wipe disinfection of the light probe is sufficient to prevent cross contamination. In addition, repeated autoclaving cycles can reduce the ability of the light probe to transmit light (55).
